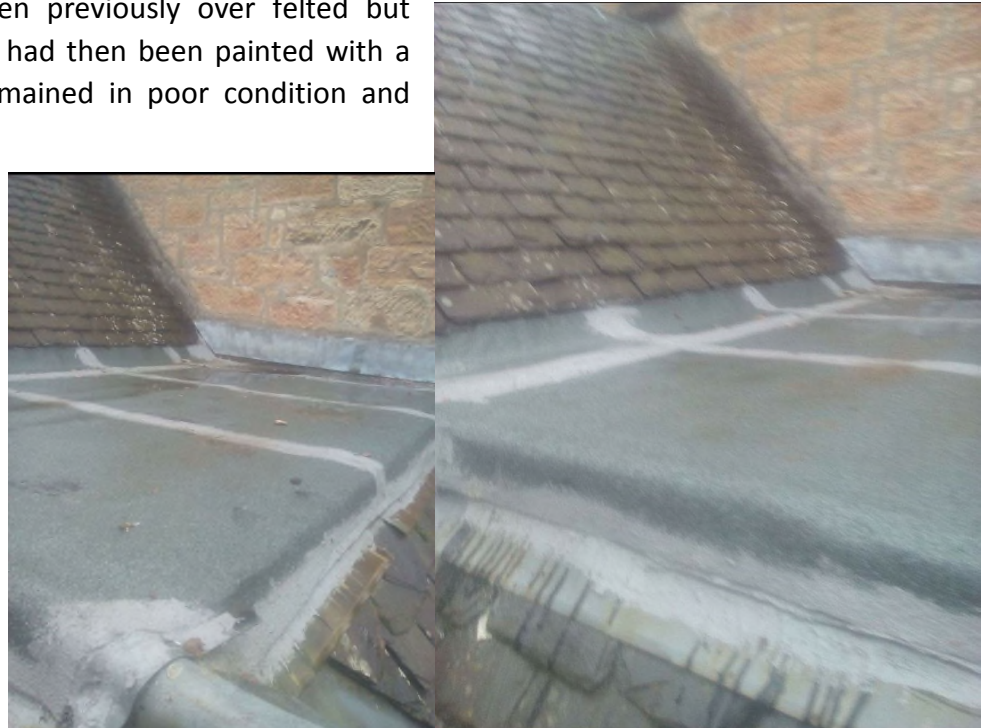
The Small flat roof had been previously over felted but continued to leak, the joints had then been painted with a mastic solution, the roof remained in poor condition and continued to leak

The roof was stripped back to the timber deck.

A new insulated built-up flat roof installed. With new lead flashings fitted at edges
