Kinross Re-Slating Works

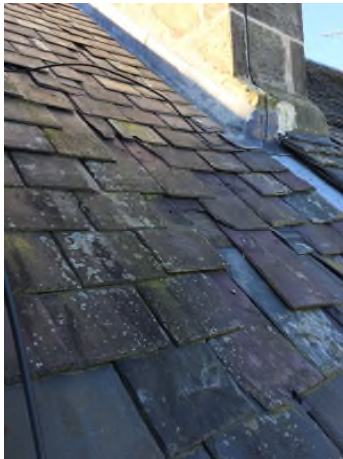
Previous rectifying works had been carried out using poor quality slates which had insufficient fixings and detailing's at flashing to dormer windows and chimneys was poorly carried out.
